FLOOD PLAIN MANAGEMENT

**A Study Of South Fork
Shenandoah Tributaries**

MILL CREEK – CONGERS CREEK

TECHNICAL REPORT
MILL CREEK - CONGERS CREEK

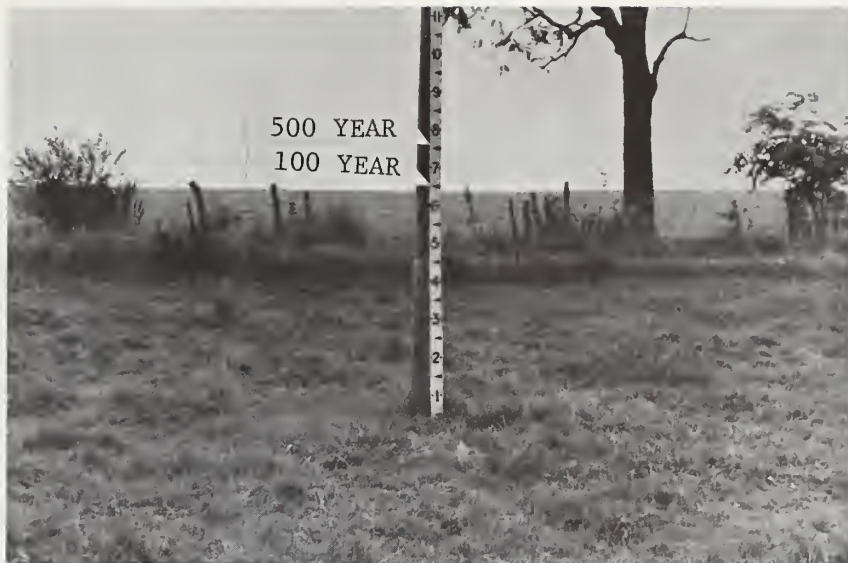
Fig 1. Potential flood stages at cross-section 23A upstream of State Route 671 over Mill Creek.

Extreme floods would inundate about 237 acres of primarily agricultural land (see Table below). Some damage would be done to the land, crops, fences, farm roads, buildings and machinery. Velocities would average about three feet per second and exceed five feet per second in some reaches. Out-of-bank stages would range from about two to seven feet. Duration of flooding would seldom exceed six hours except during storms of intense and prolonged rainfall. Figure 1 and Figure 2 show potential flood stages.

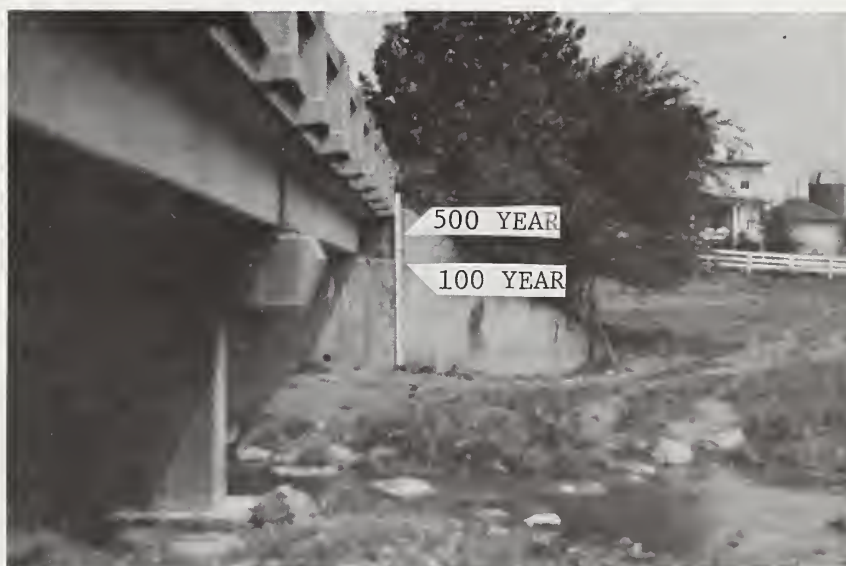
Fig 2. Potential flood stages at cross-section 21, State Route 659 over Mill Creek.

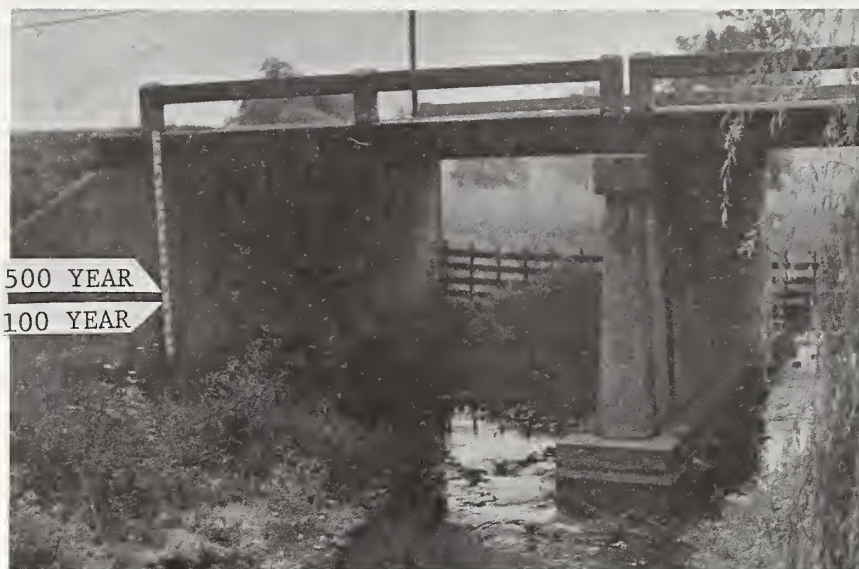
Fig. 3 Potential flood stages at cross-section 54,
State Route 276 over Congers Creek.

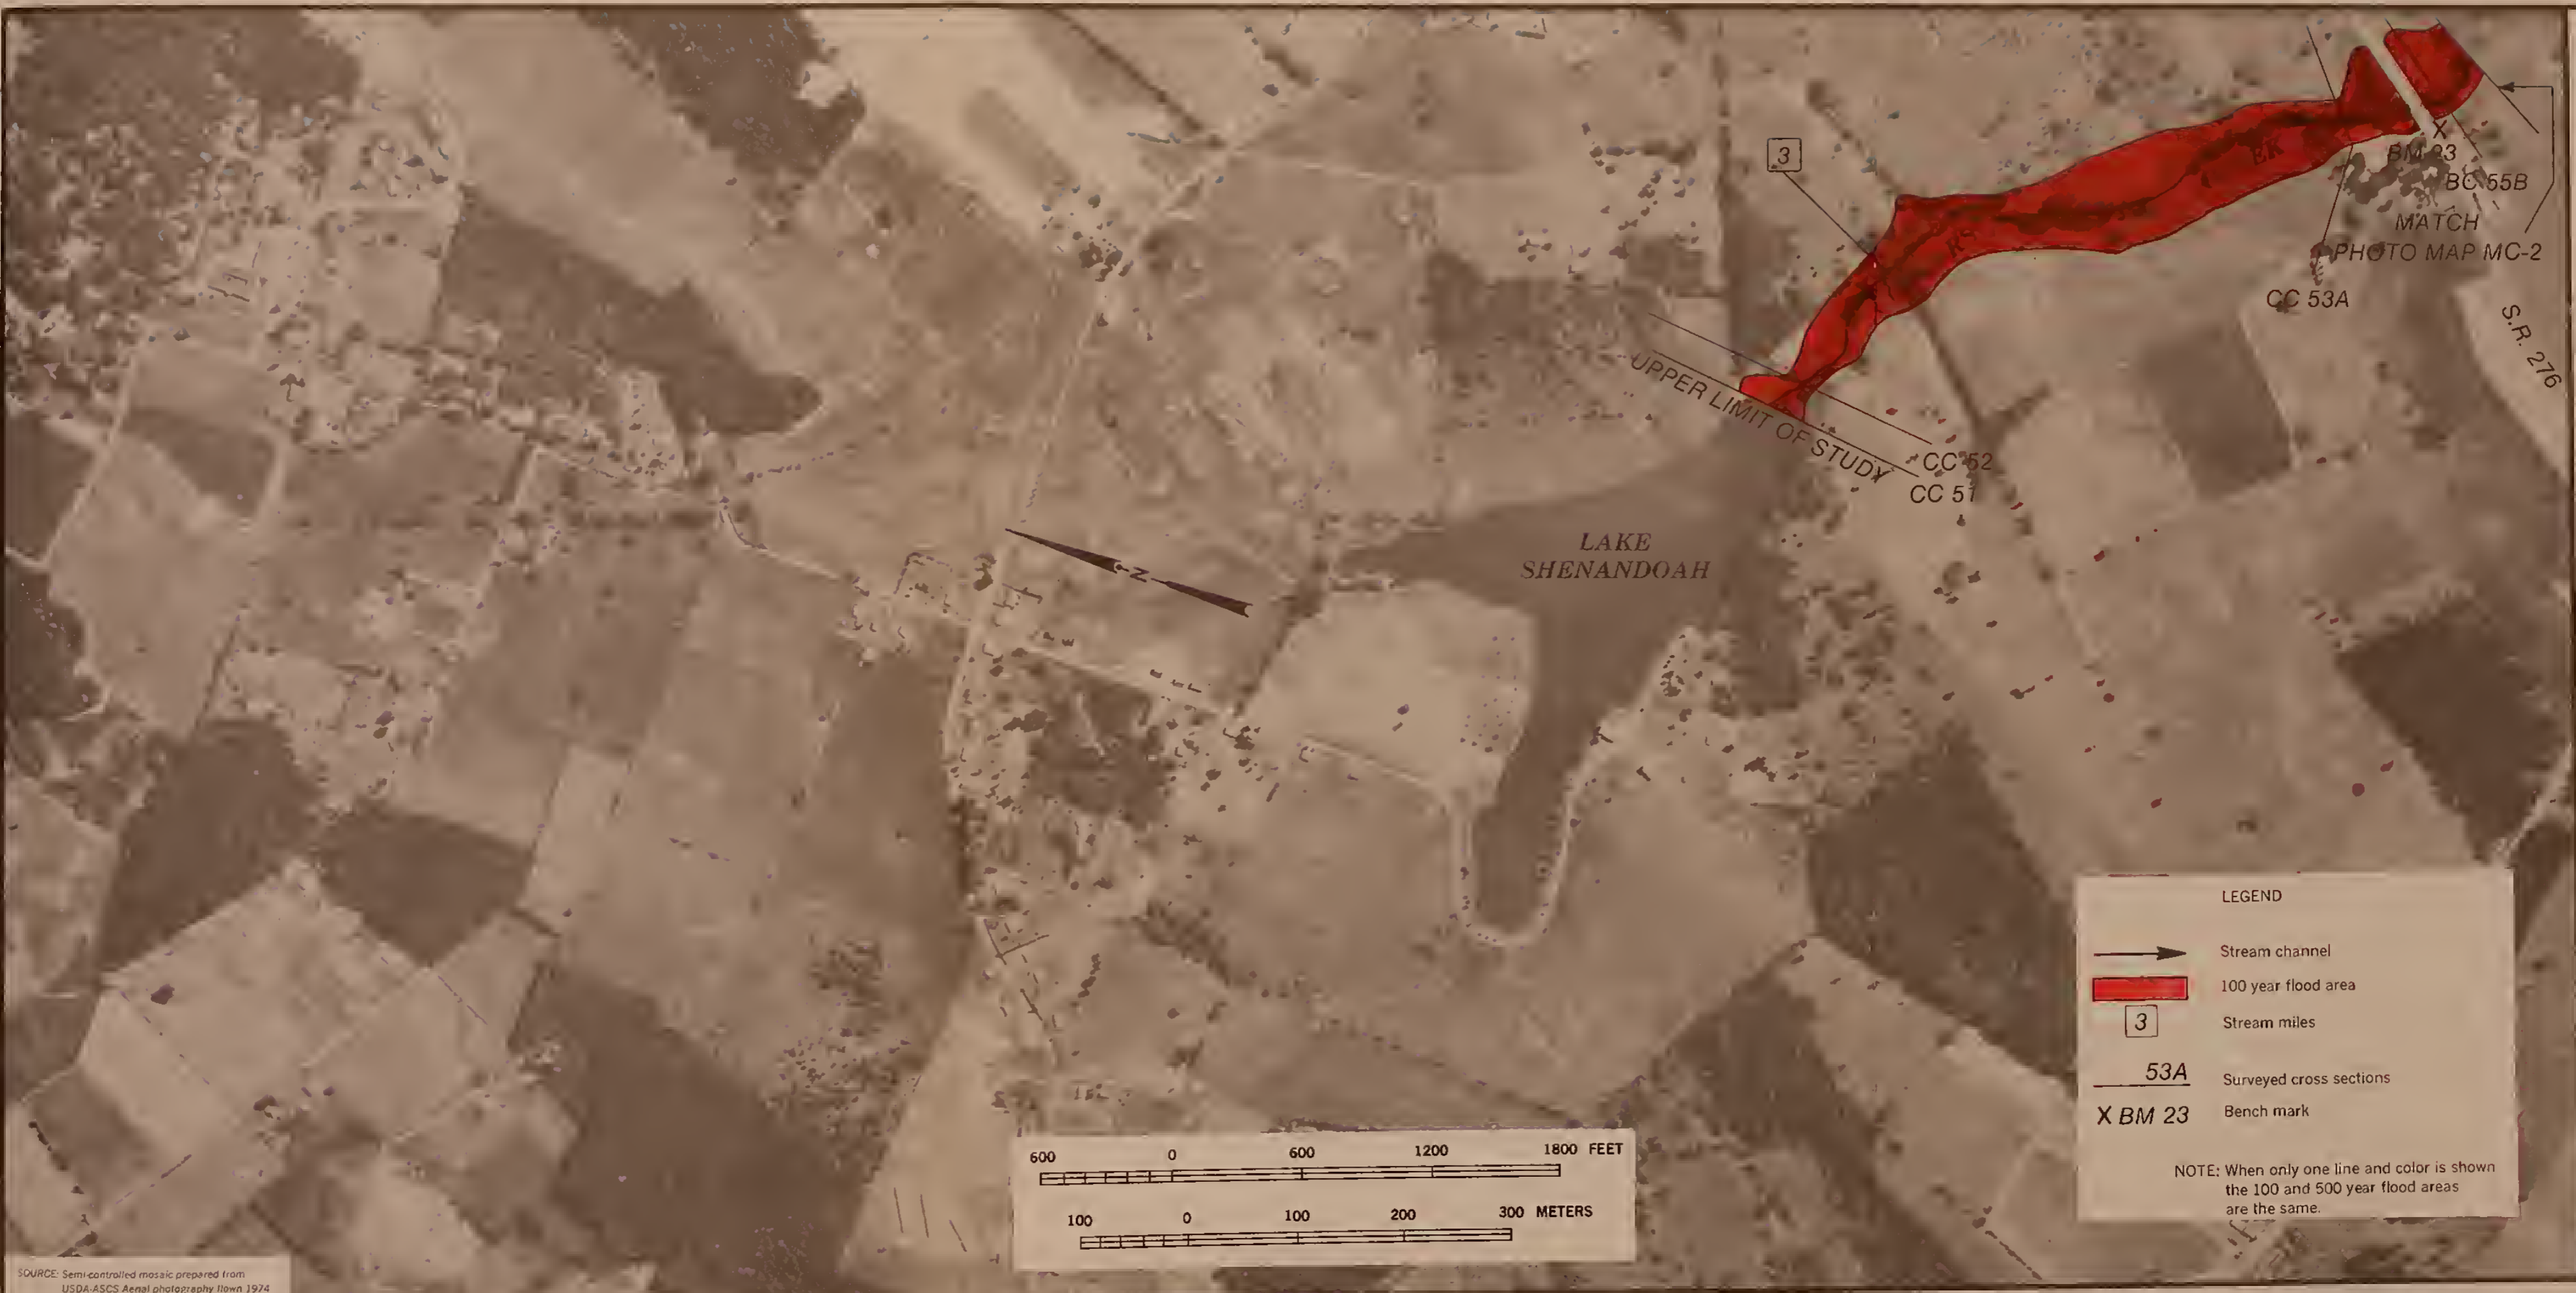
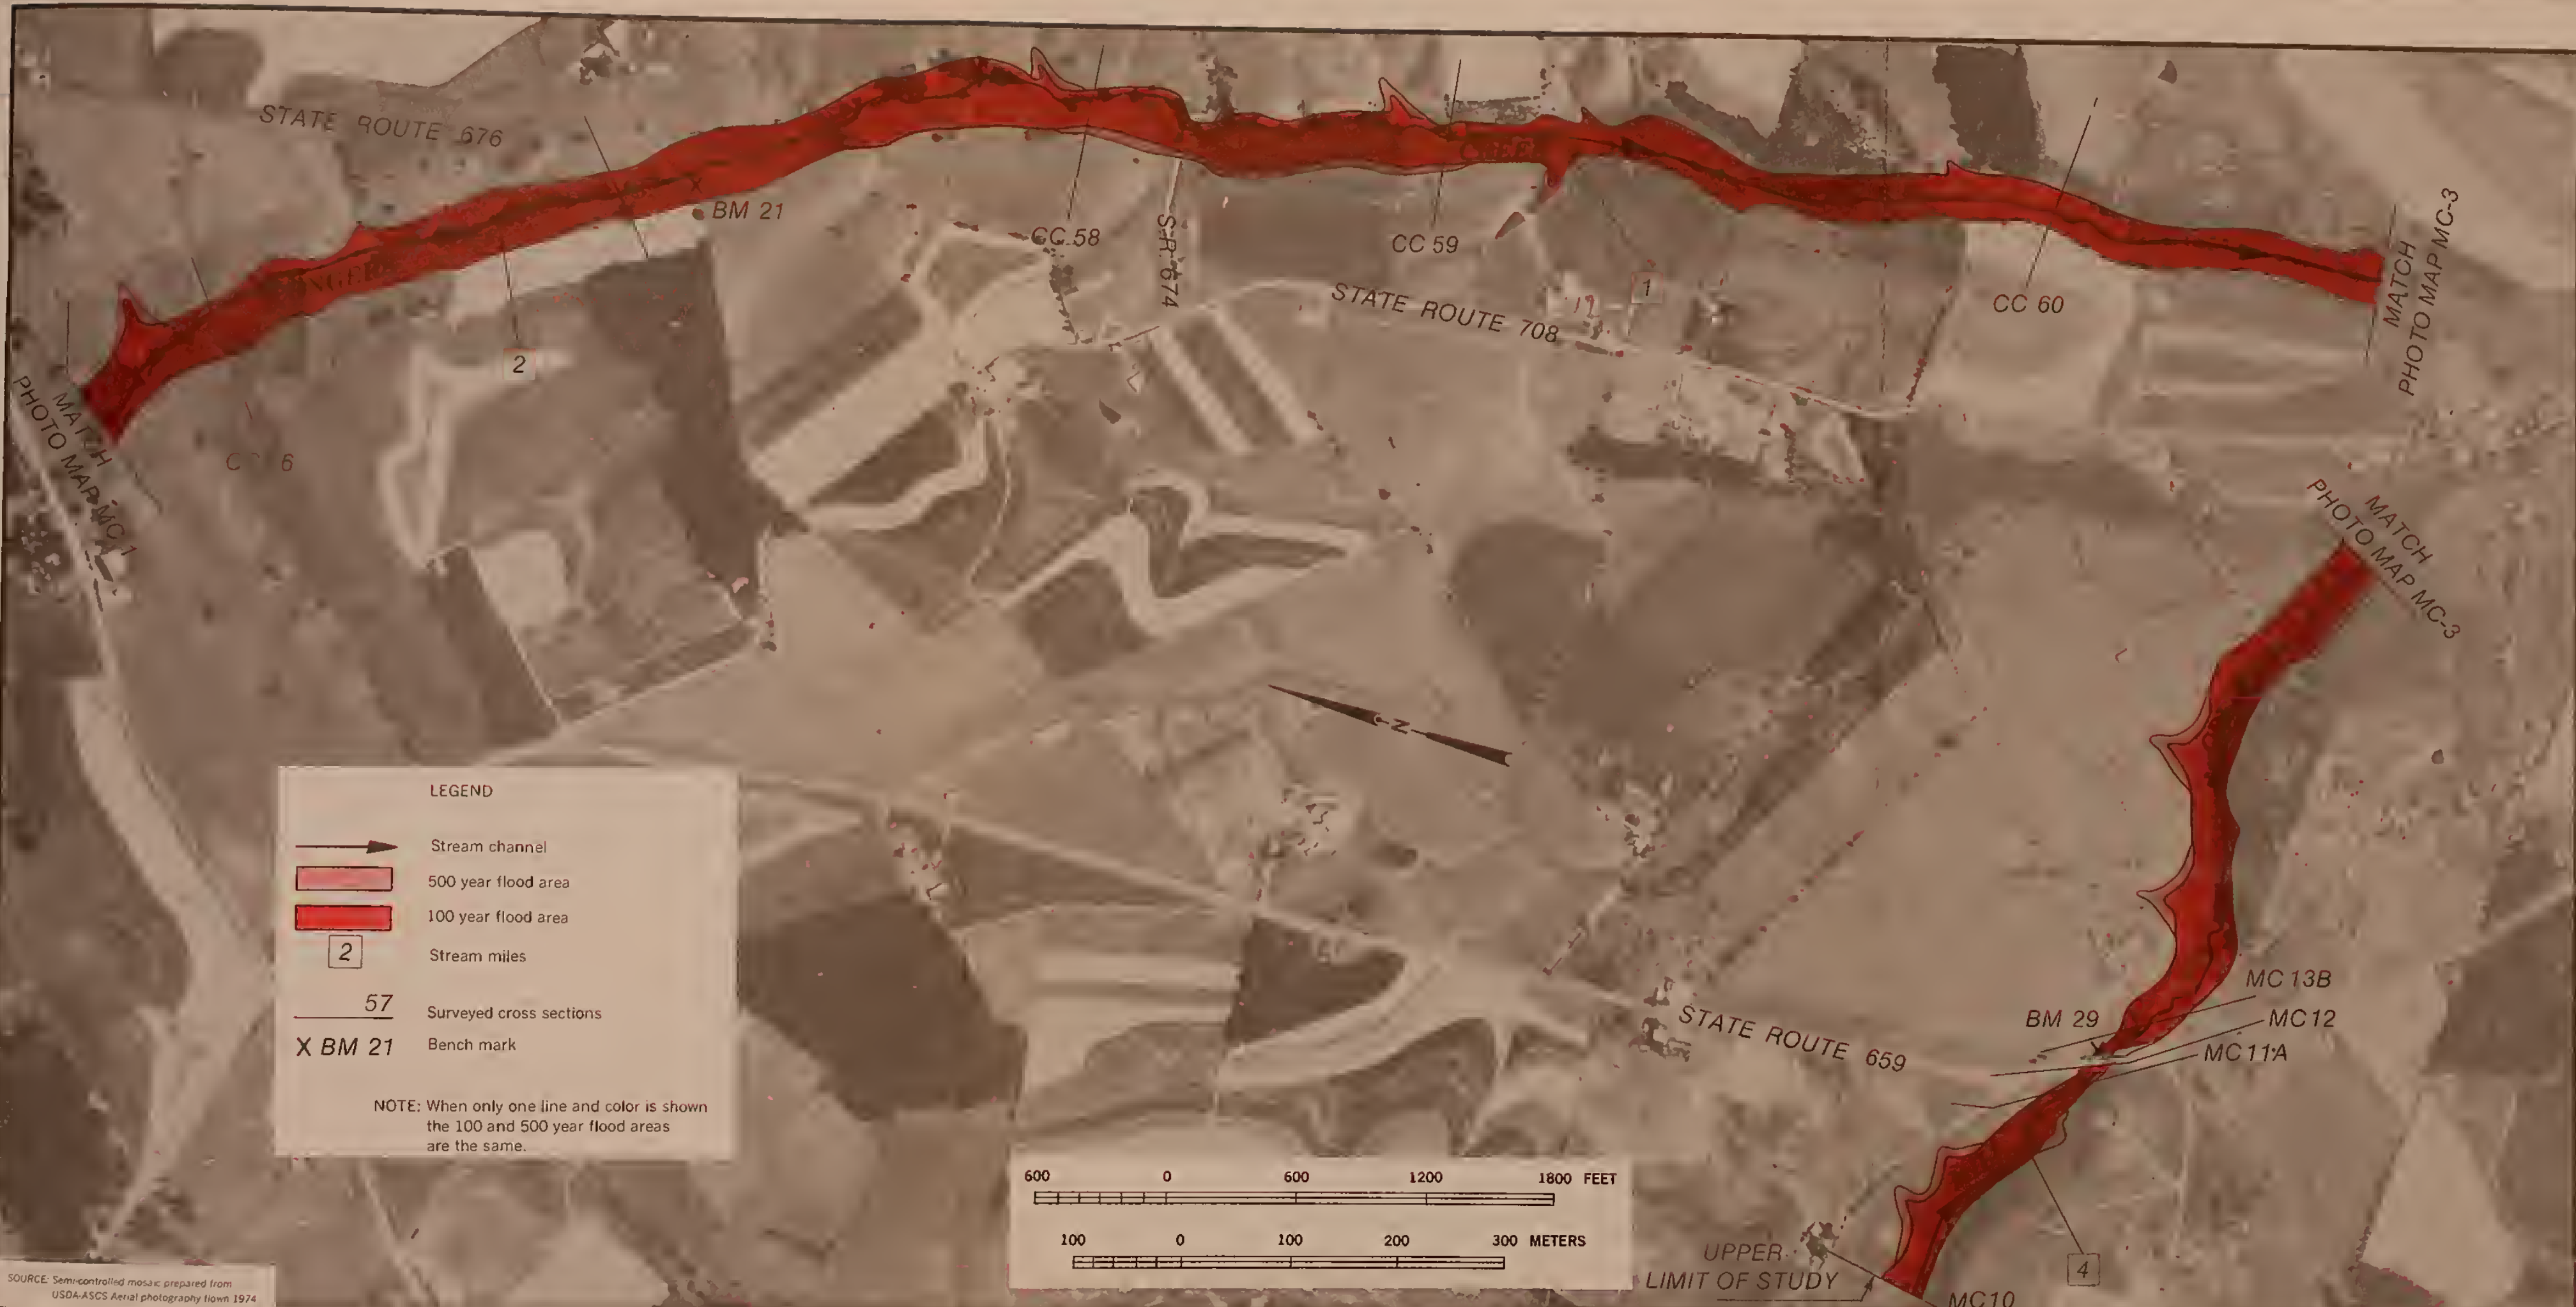
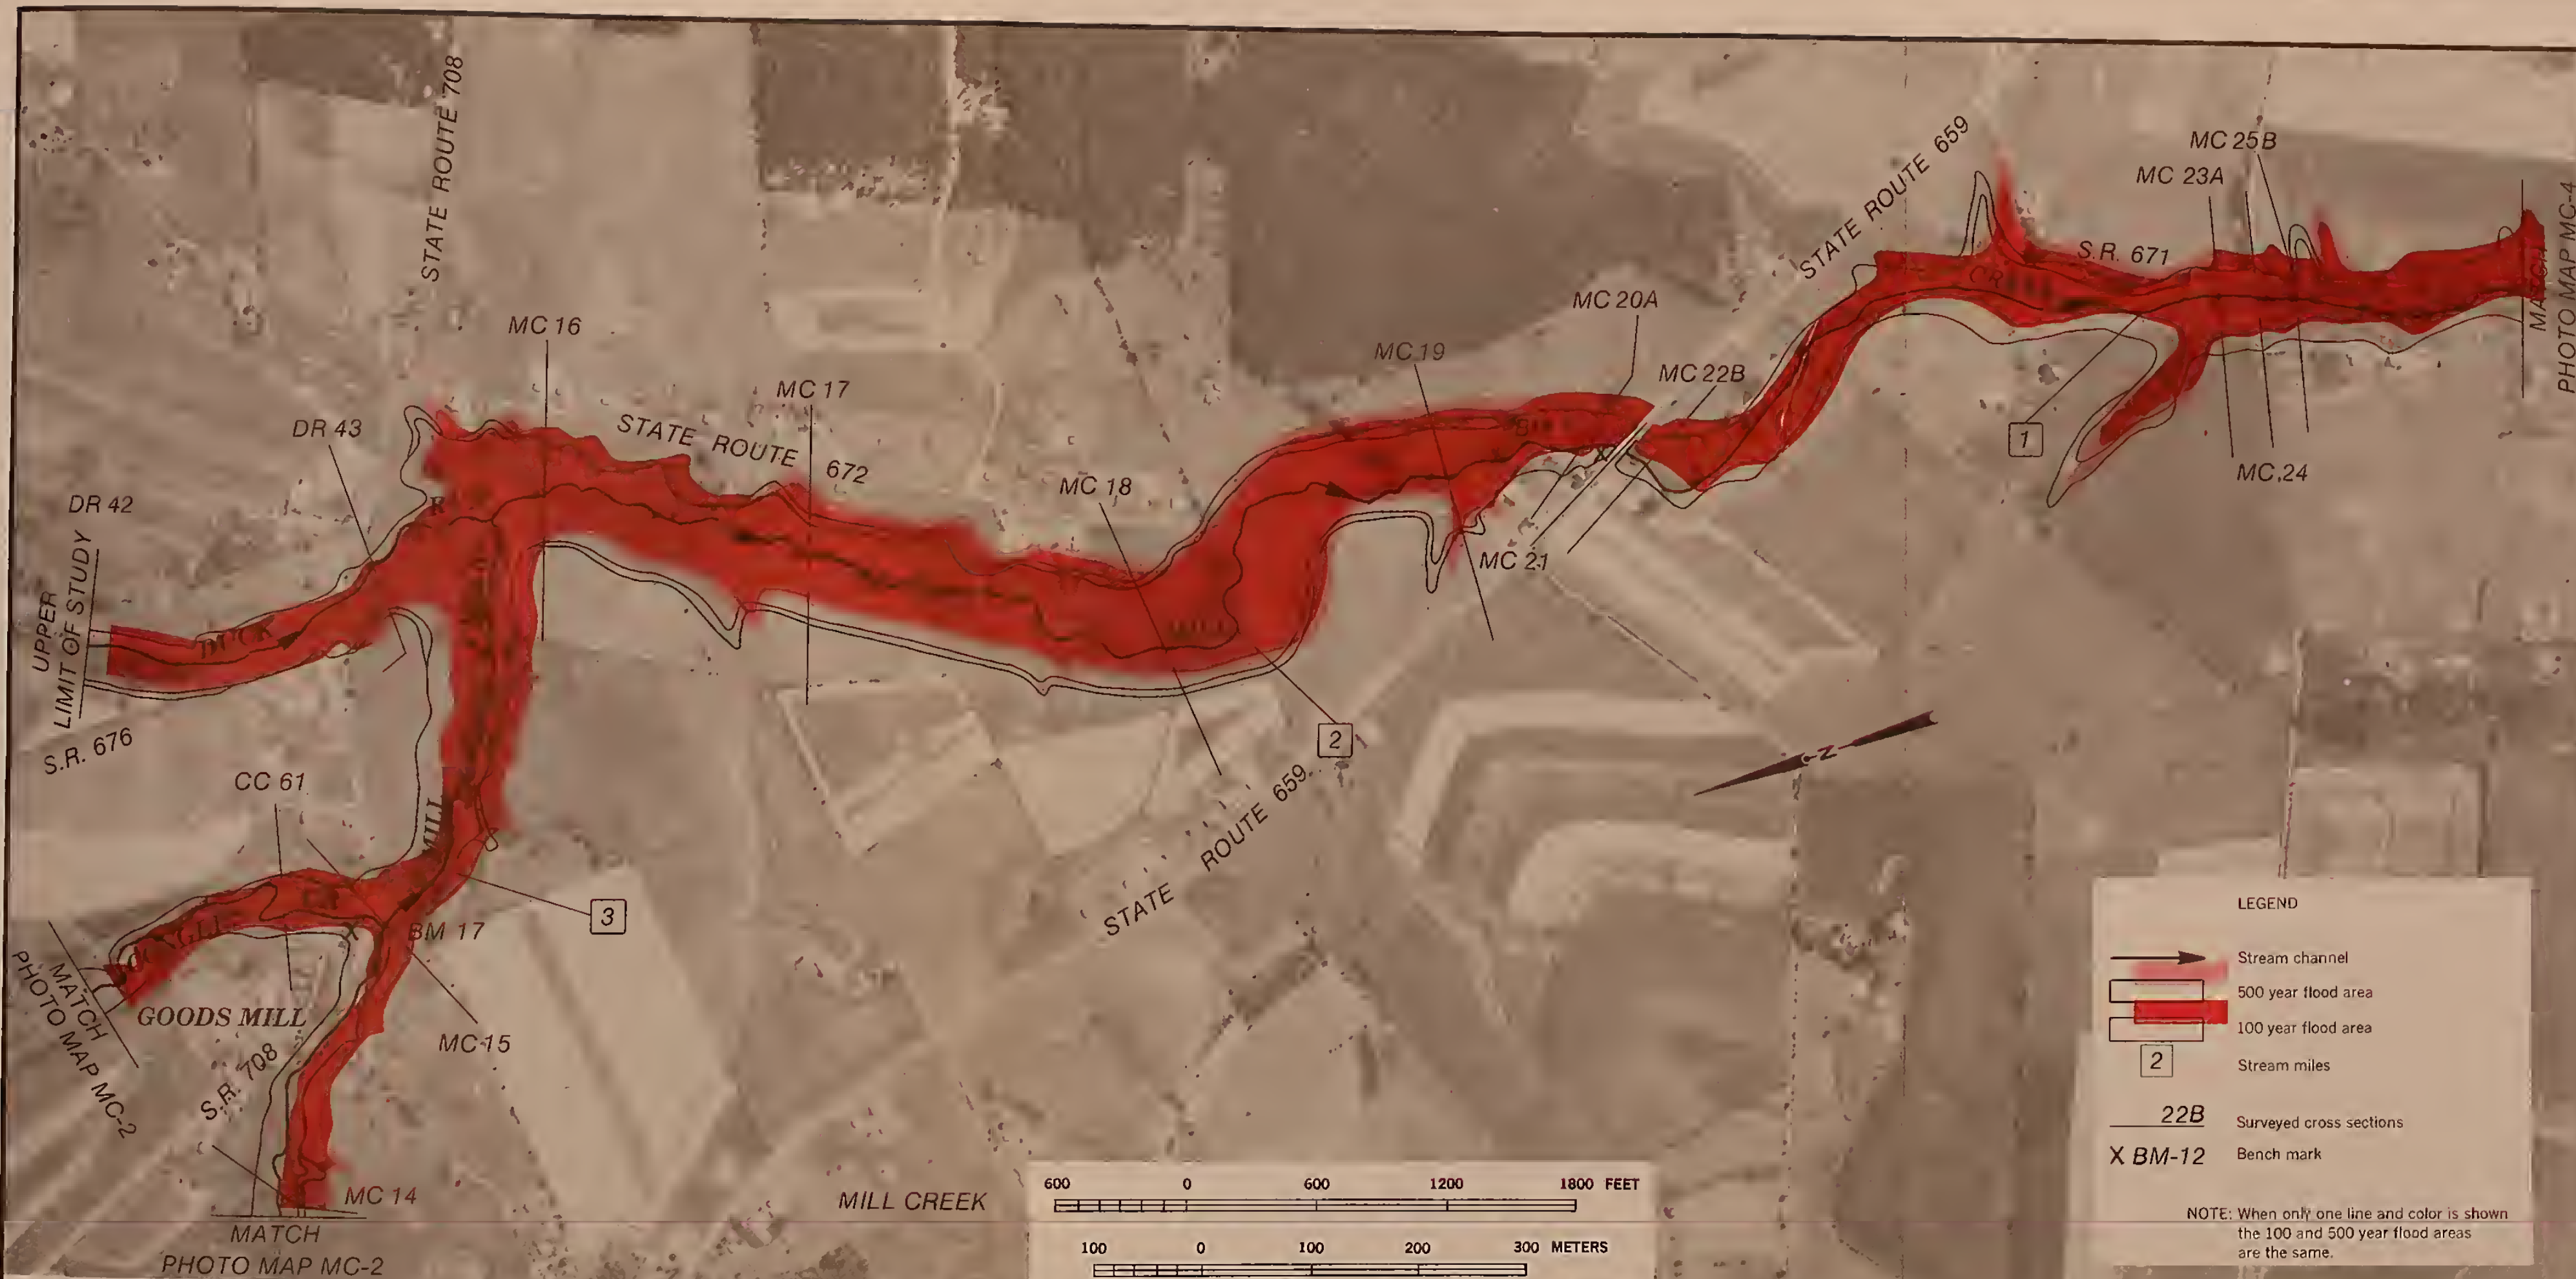
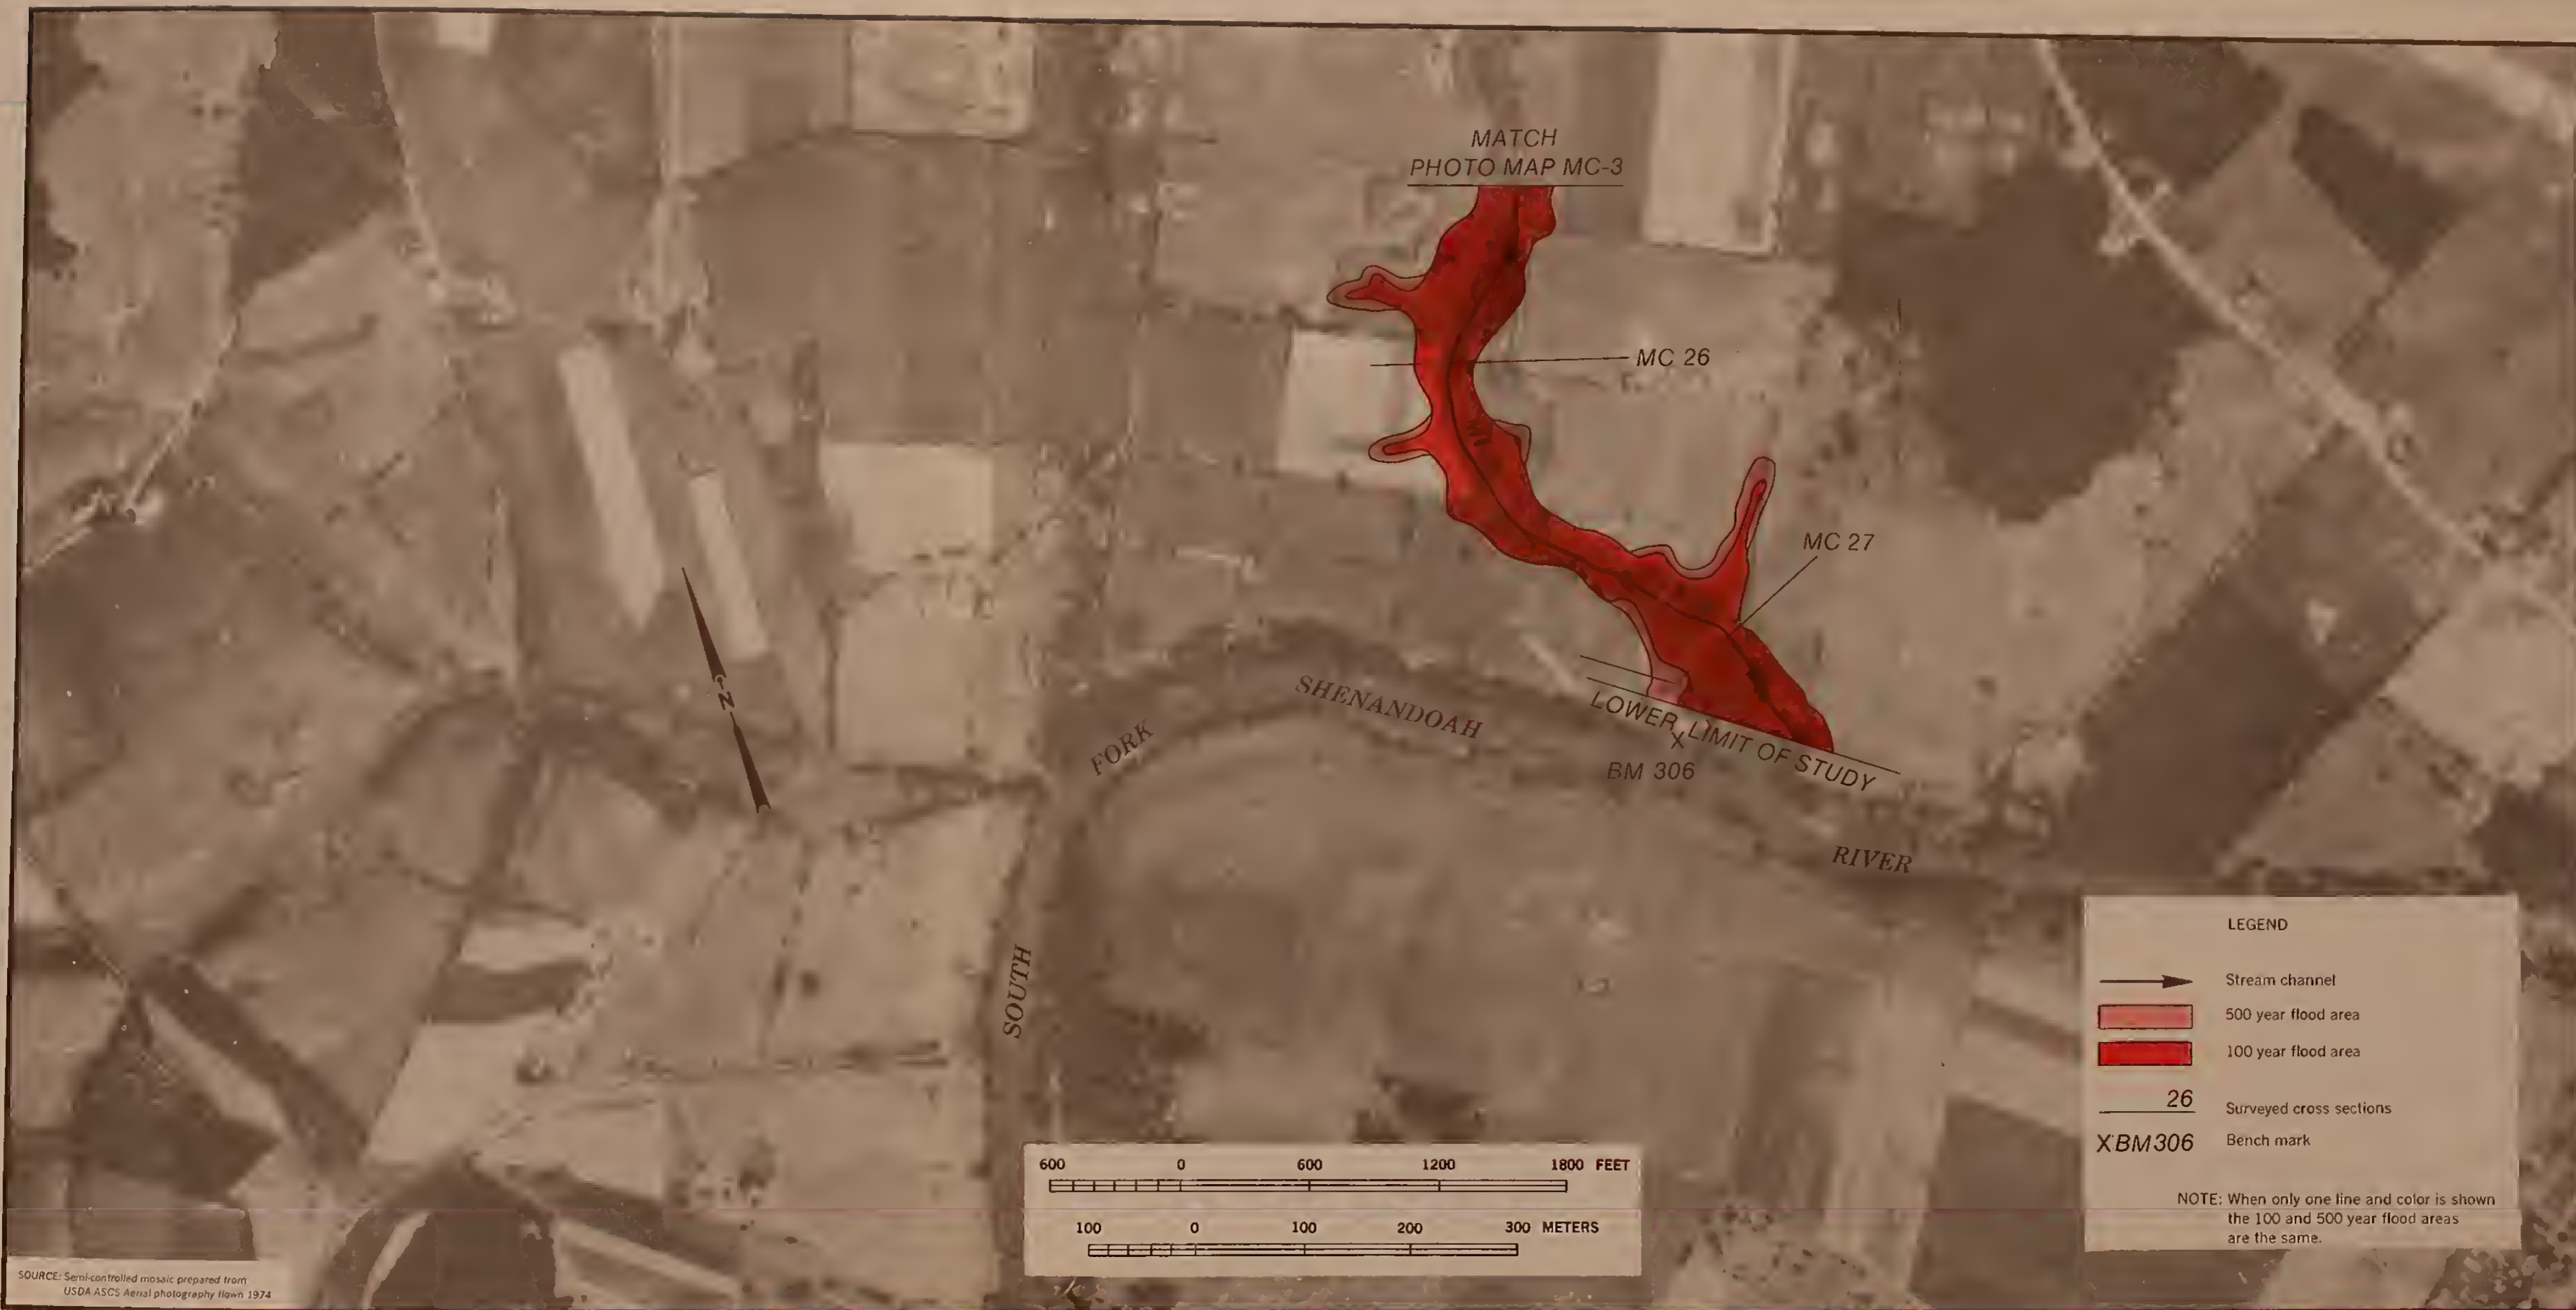
The index map shows the area covered by the individual photomaps. Flood hazard photomaps show the area inundated by the 100 and 500-year floods. Where only one line is shown, there is no significant difference in the boundaries of the two flood areas. These photomaps should only be used to determine approximate flood elevations; they are based on semicontrolled mosaics and the boundaries shown may vary from the location on the ground.

1. On the appropriate photomap find the point on the stream where the flood line is to be located; then scale the distance along the stream to the nearest cross section.

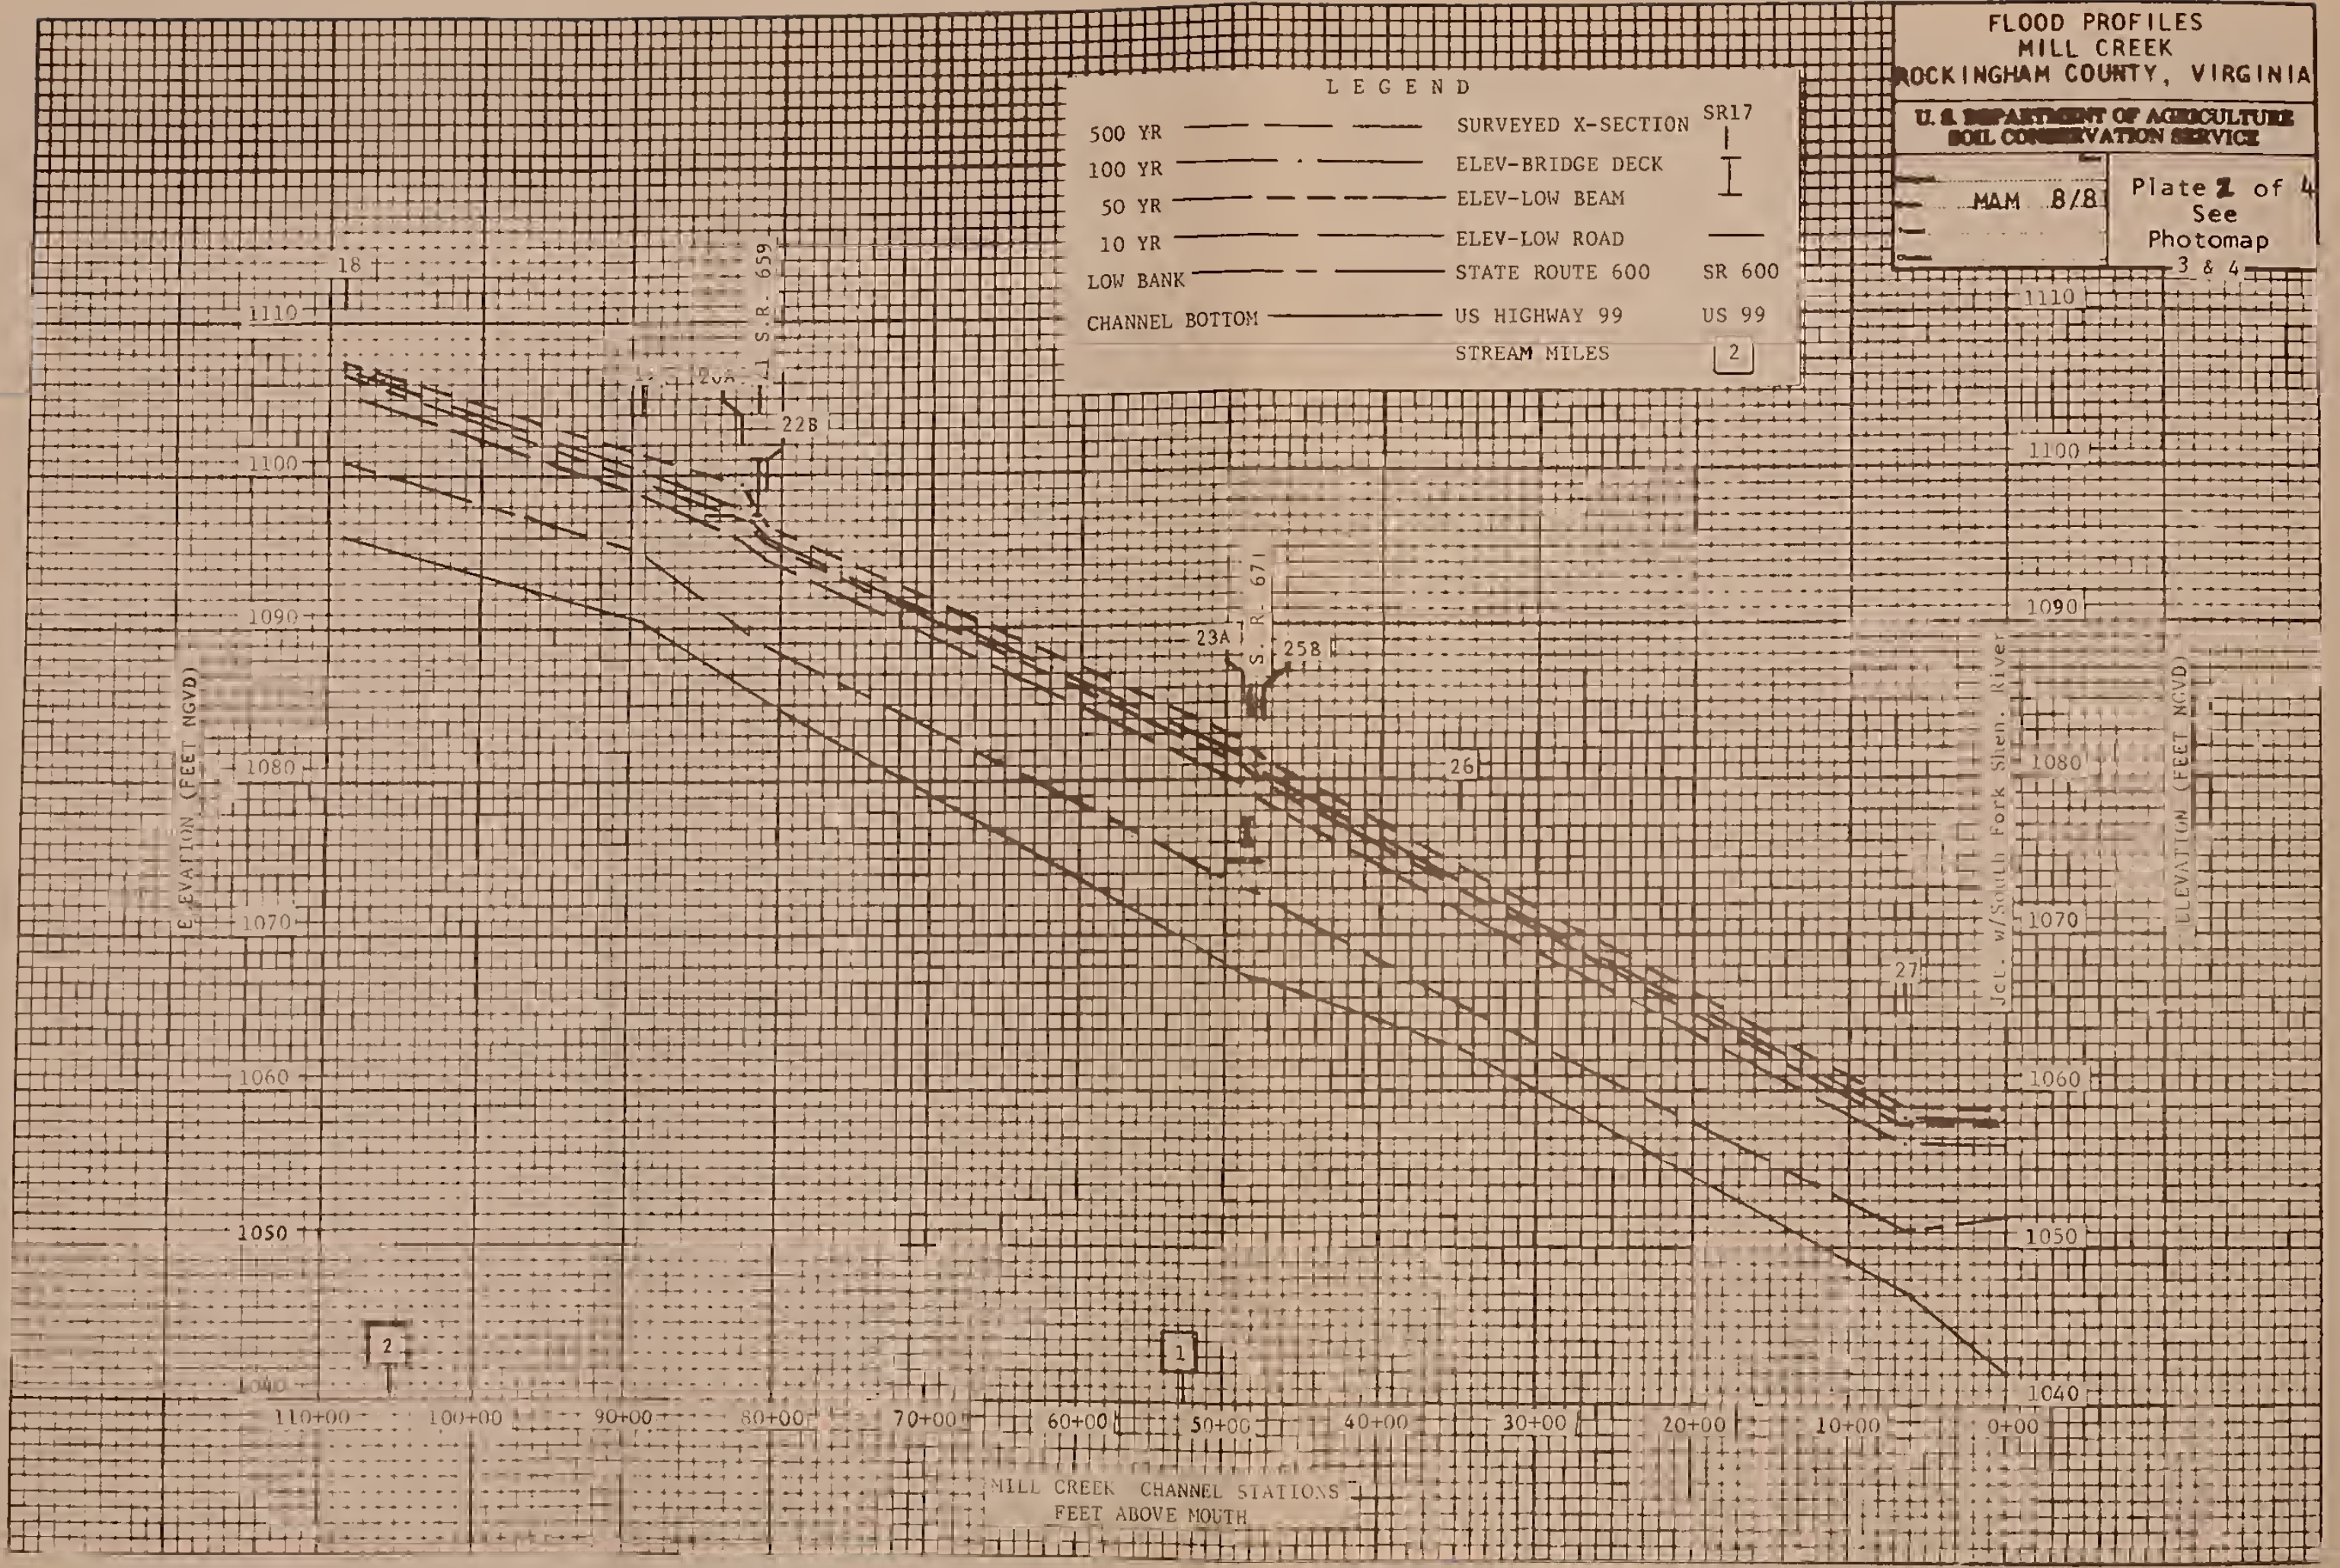
MAM 8/81 Plate 3 of 4
 See
 Photomap
 2 & 3

FLOOD PROFILES
CONGERS CREEK,
TRIB OF MILL CREEK
ROCKINGHAM COUNTY, VIRGINIA
U. S. DEPARTMENT OF AGRICULTURE
SOIL CONSERVATION SERVICE

Flood profile plates provide elevations of the 10, 50, 100 and 500-year floods at any location along the length of the streams. The elevations and discharges of the 10, 25, 50, 100 and 500-year flood at each surveyed cross section are given in Table MC-1. Sample cross sections illustrated how the flood area boundaries were located. Table MC-2 provides the description and elevation of benchmarks which are located on the photomaps.

2. On the appropriate flood profile sheet, scale the distance determined in Step 1 from the cross section back to the original stream location, and read the elevation of the desired flood frequency line.
3. Transfer the elevation determined in Step 2 to the ground from the nearest established benchmark.

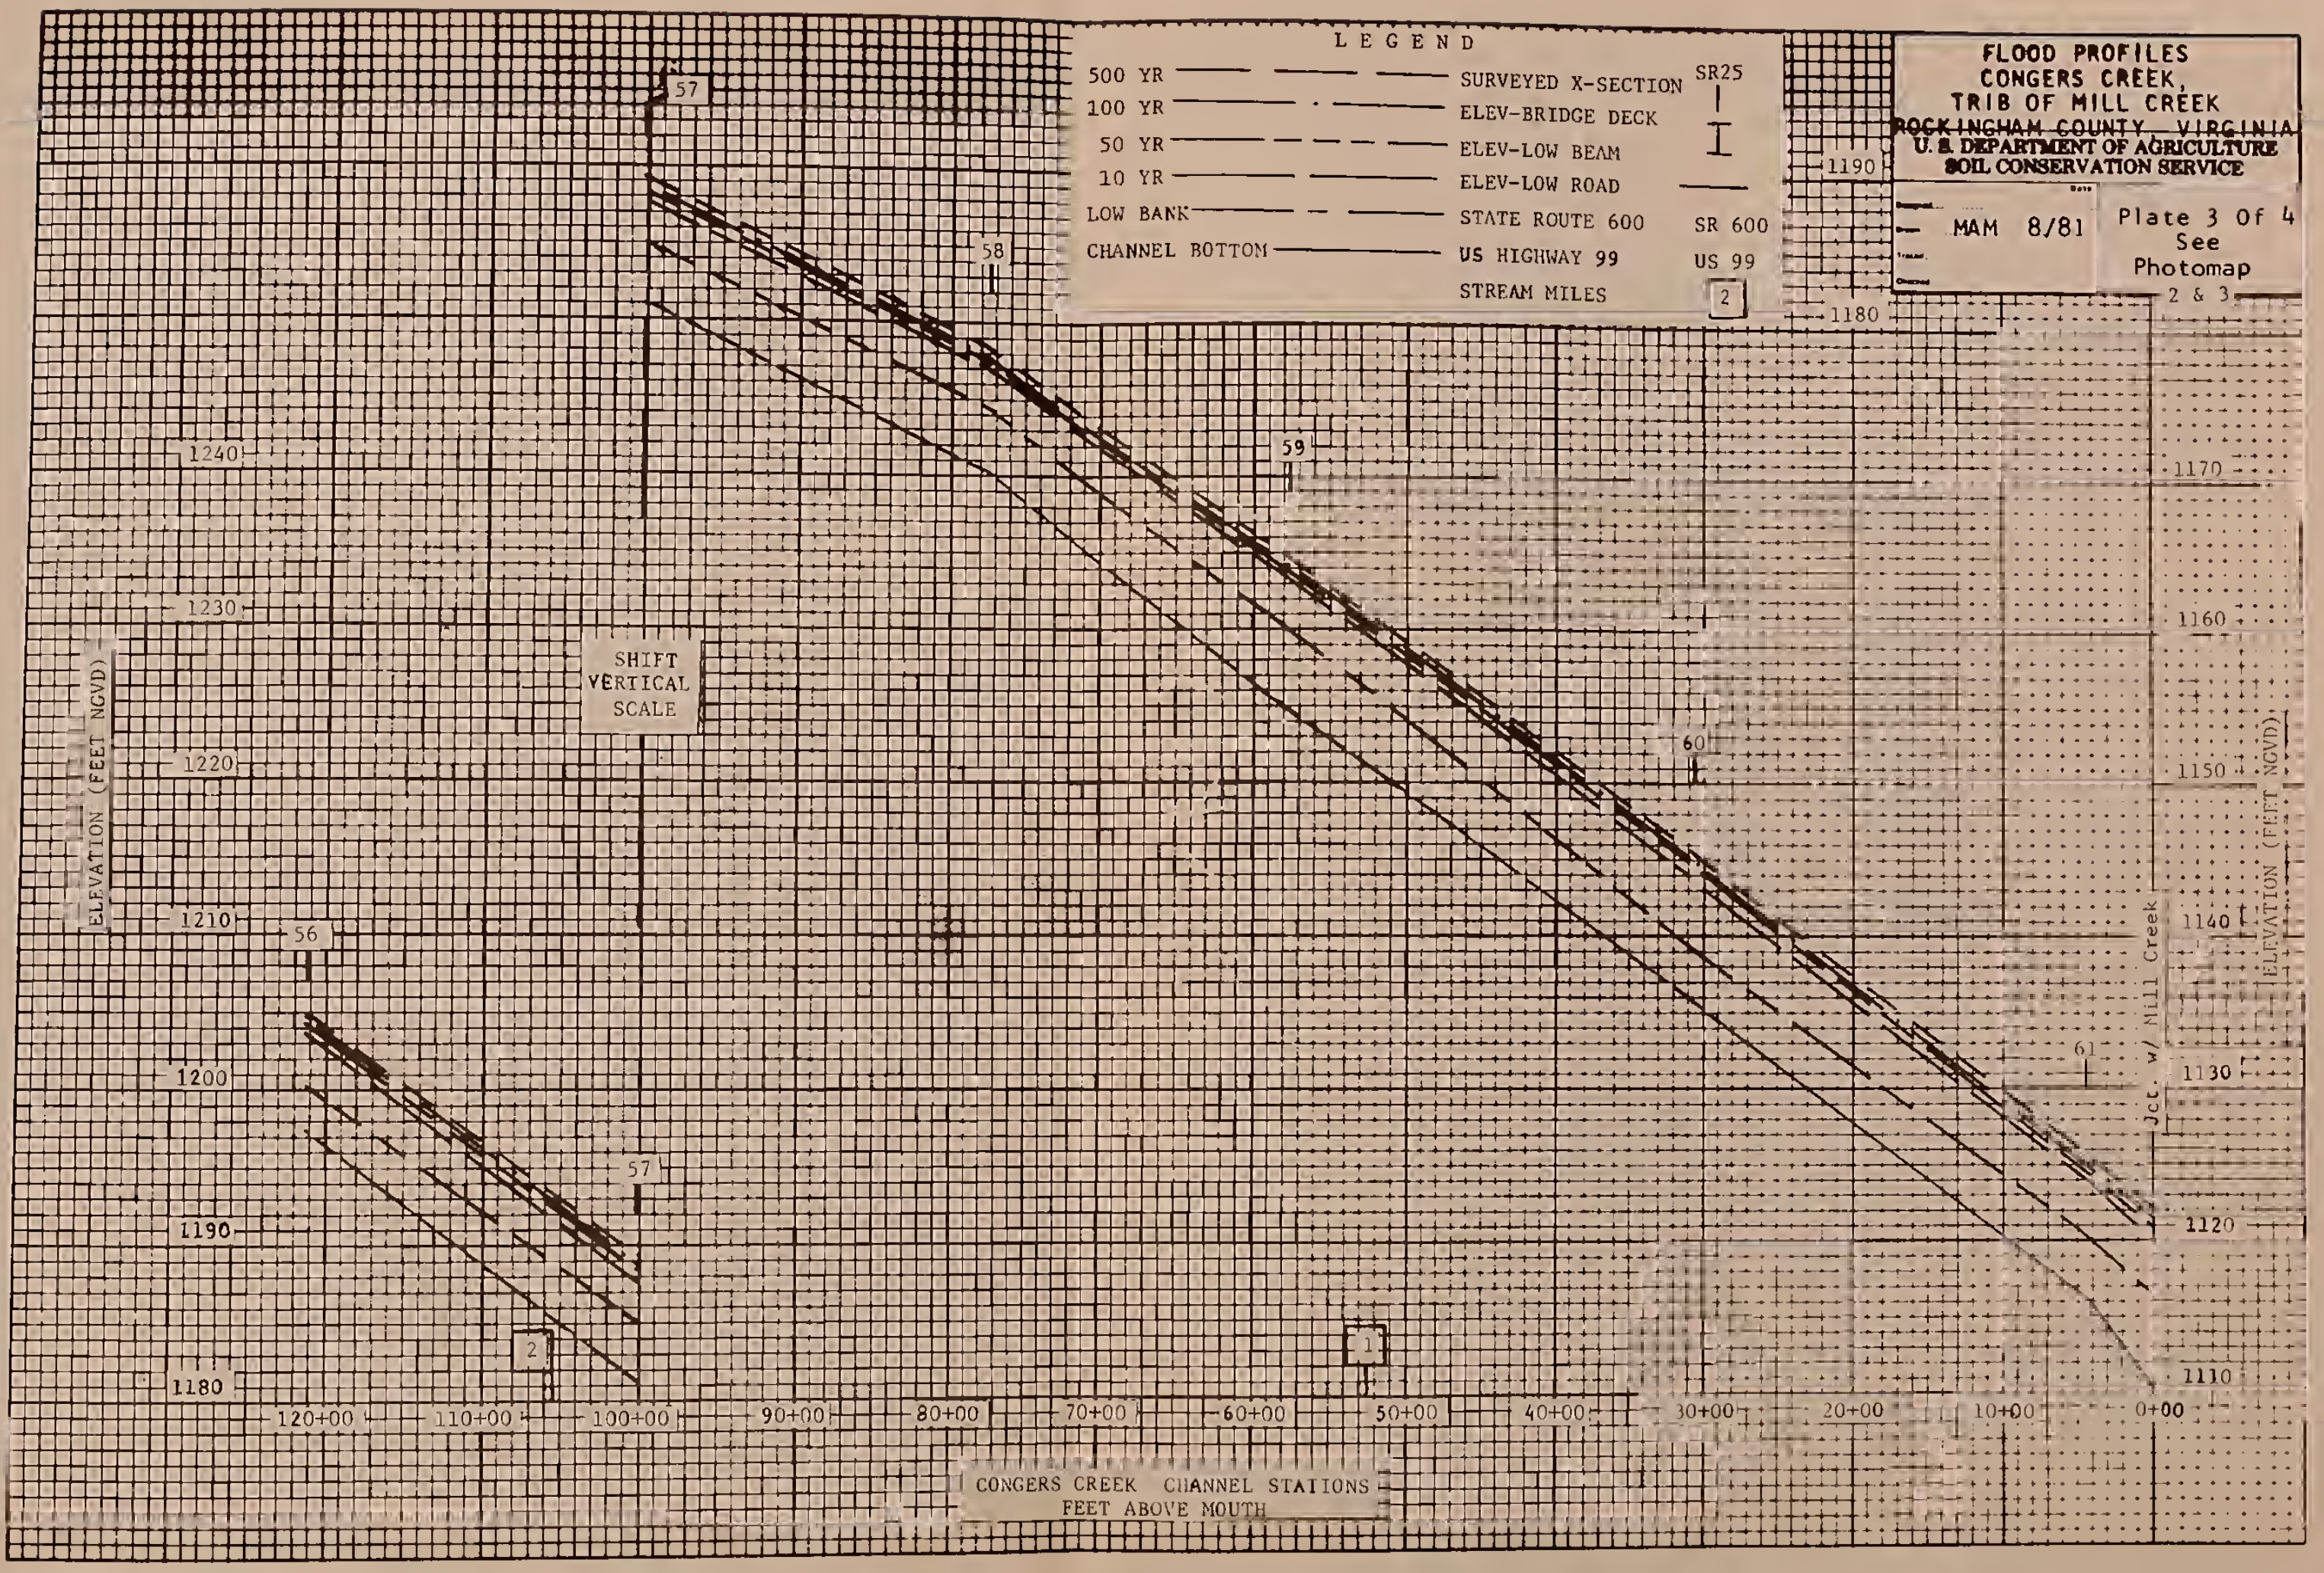
Plate 4 of 4
See
Photomap
1, 2 & 3

FLOOD PROFILES
CONGERS CREEK & DUCK RUN
ROCKINGHAM COUNTY, VIRGINIA
U. S. DEPARTMENT OF AGRICULTURE
SOIL CONSERVATION SERVICE
